SUBJECT: Casper Alcova Irrigation District
Teranap 431 Canal Liner Project: 20-Year Evaluation

RTD LABORATORY REPORT

Project Name:	Casper Alcova Irrigation District
Project Location:	Casper, WY
Construction Date:	Completed January 1991
Area of Membrane Installation:	Approximately 2,000,000 square feet

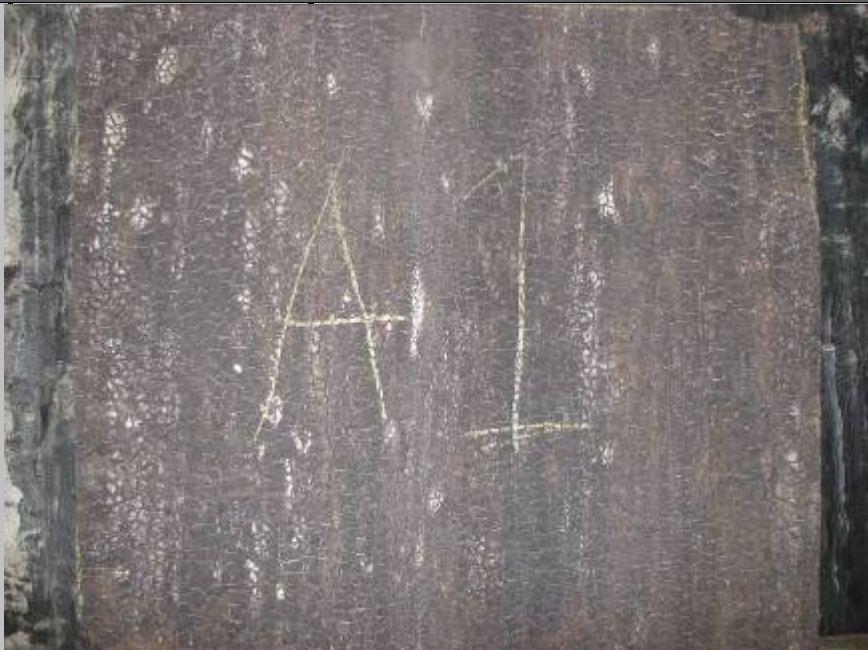
Sample Description: Sample Size and Surface Appearance		
Sample #A1	Size: 590 in ² (4.1 ft ²)	Comments: Cracking was observed on the surface of the Teranap.

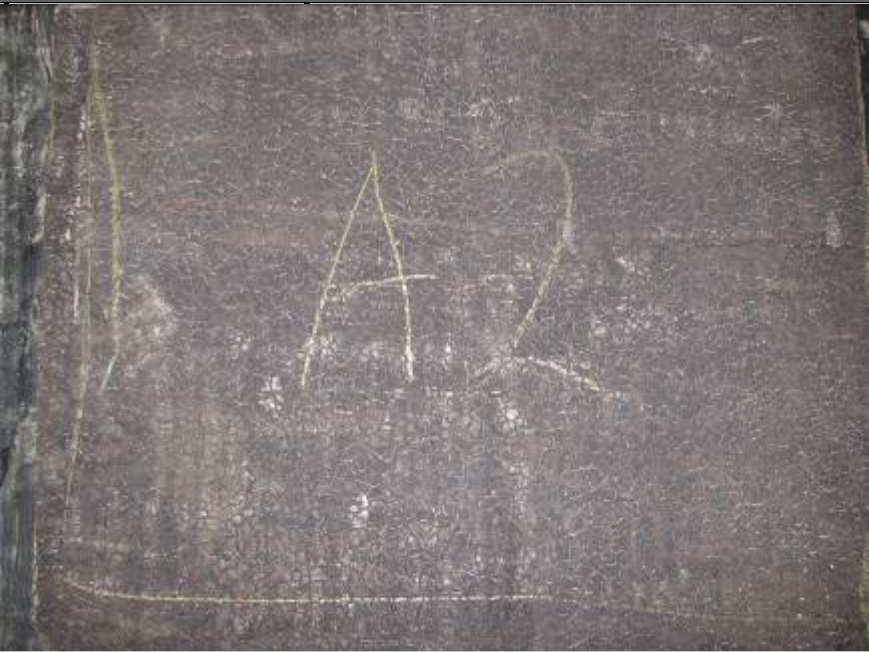
Sample Description: Sample Size and Surface Appearance		
Sample #A2	Size: 675 in ² (4.7 ft ²)	Comments: Crazing was observed on the surface of the Teranap.

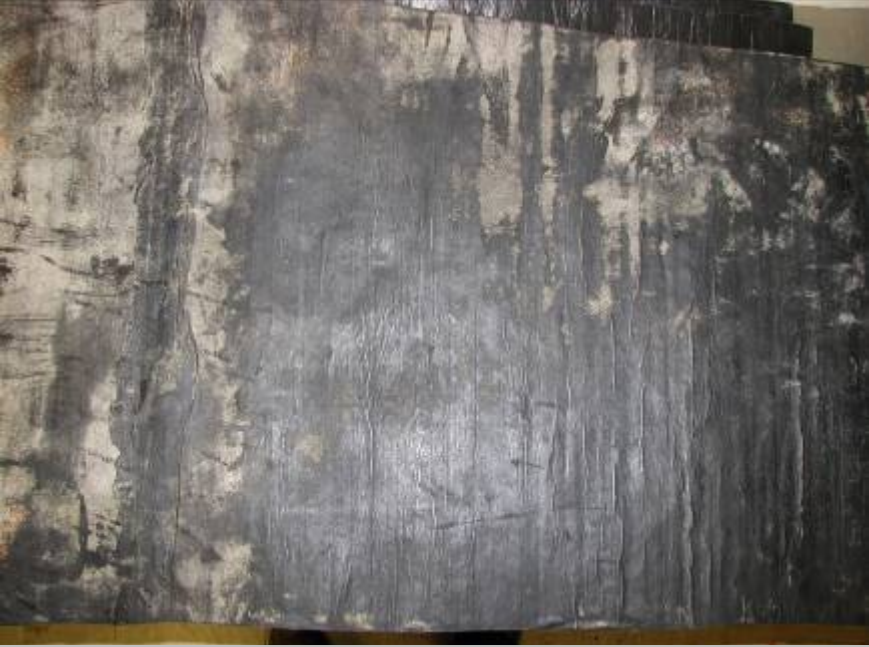
Sample #B1	Size: 1279 in ² (8.9 ft ²)	Comments: No obvious signs of product or application issues were visible on the surface of the sample.

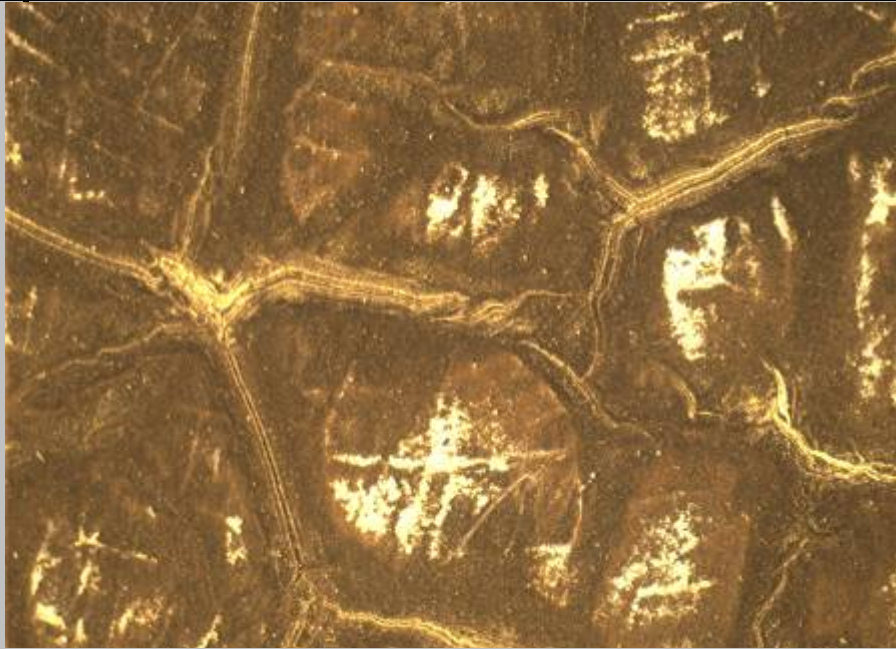
**Sample
#A1**

The microscope image indicates alligating in the surface of the Teranap.

1. Samples A1 and A2 were taken from the upper wall of the irrigation canal where the membrane was directly exposed to UV light and the elements. These samples exhibited alligatoring on the surface. Microscope imagery indicated that the depth of the crazed SBS bitumen waterproofing did not penetrate to level of the reinforcement within the cross-section of the Teranap.

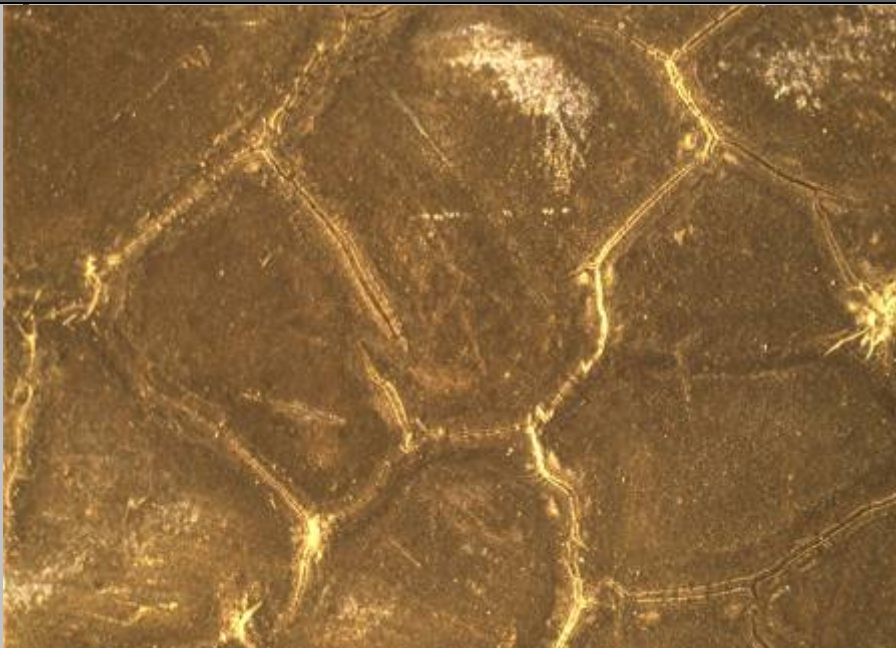
**Sample
#A2**

The microscope image indicates alligating in the surface of the Teranap.

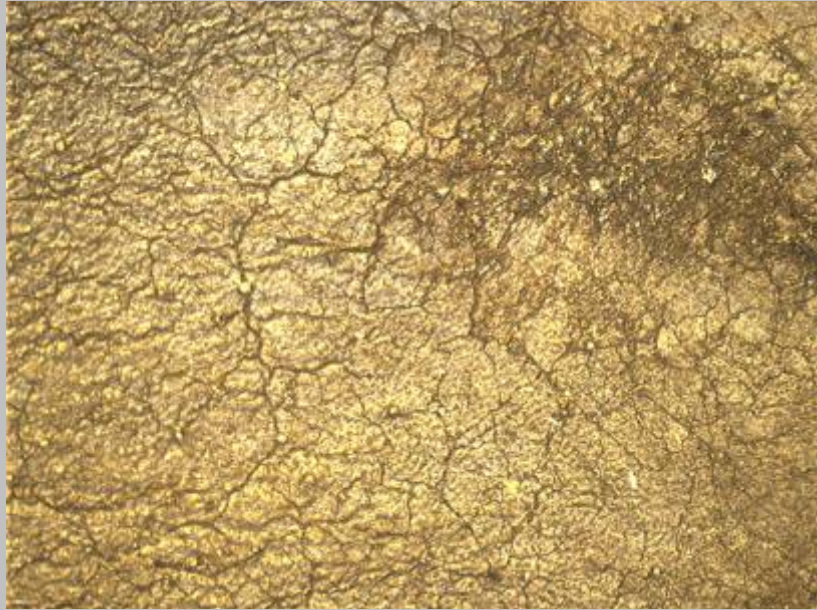
Sample #
B1

The microscope image indicates checking (minor crazing) on the surface of the Teranap.

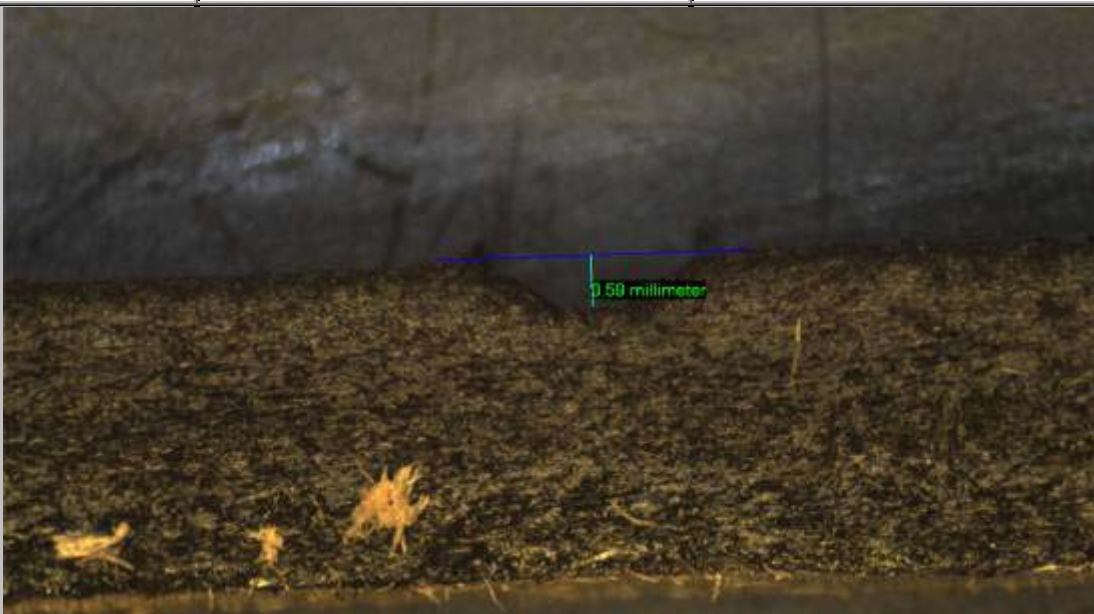
Sample #A1

Although alligatoring occurred on the surface of the membrane on samples A1 and A2, it had not reached the level of the reinforcement within the cross-section of the membrane. Based on the average depth of the crazing channels, less than 15% of the total membrane thickness was penetrated.

Average Channel Depth
23 mils (0.58 mm)

Reinforcement Depth
40 mils (1.02 mm)

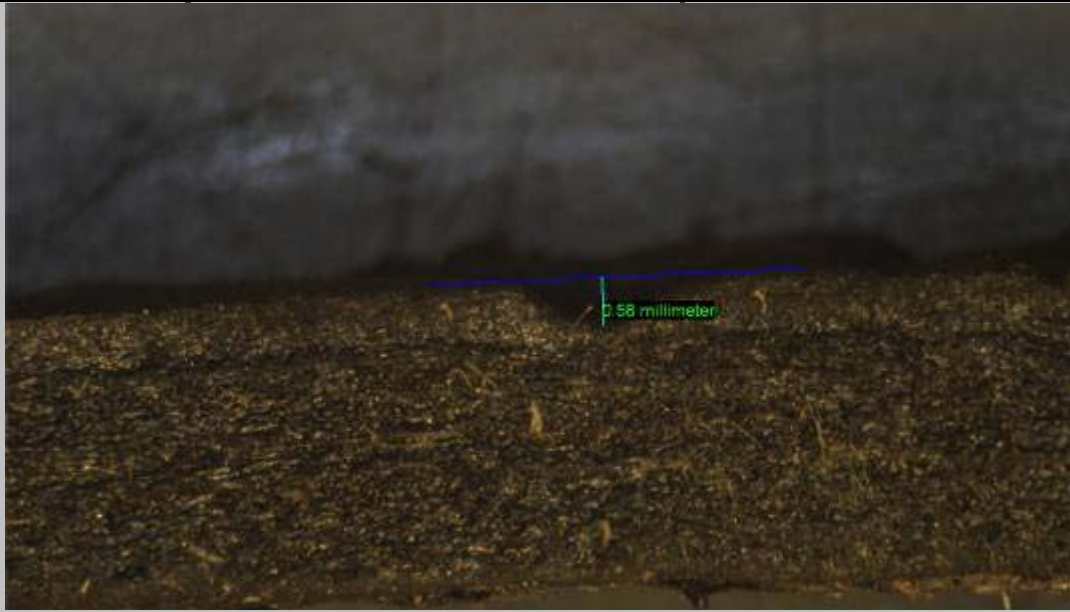
Sample #A2	Average Channel Depth 21 mils (0.54 mm)	Reinforcement Depth 28 mils (0.70 mm)
-------------------	---	---

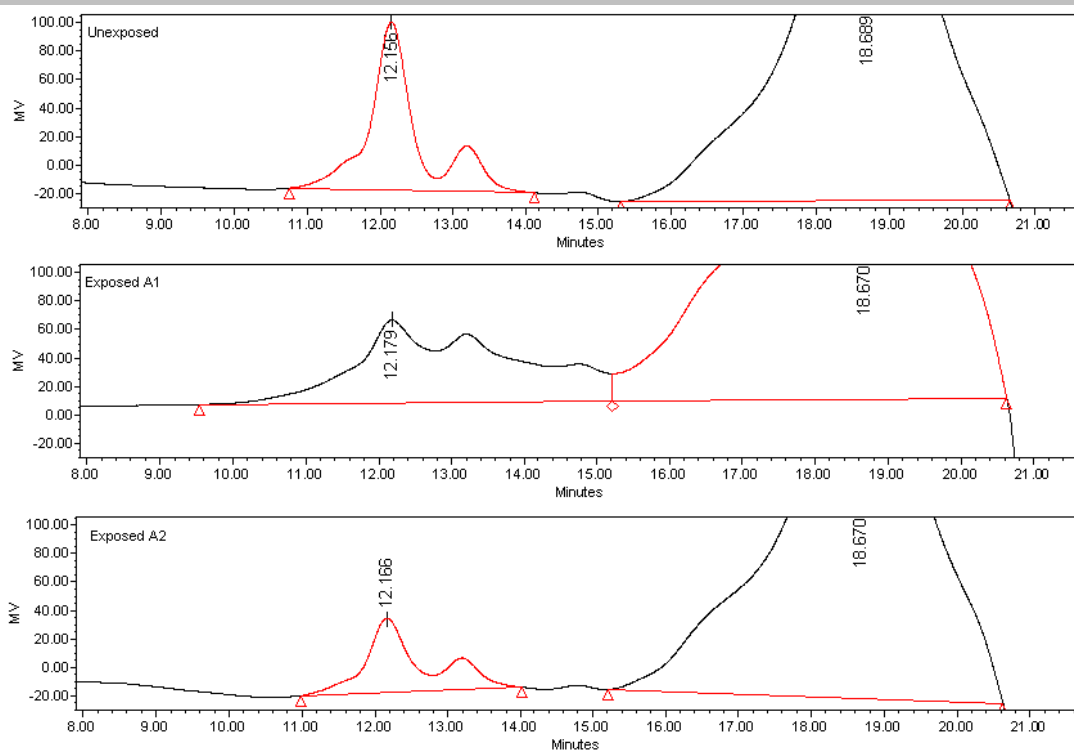
Comments: The image compares the GPC curves for the individual samples. Based on the results there appears to be some polymer degradation in the exposed samples.

5. GPC (gel permeation chromatography) analysis was performed on the SBS bitumen, and the exposed samples experienced a higher rate of polymer degradation than B1, however active (intact) SBS polymer remained in both A1 and A2.

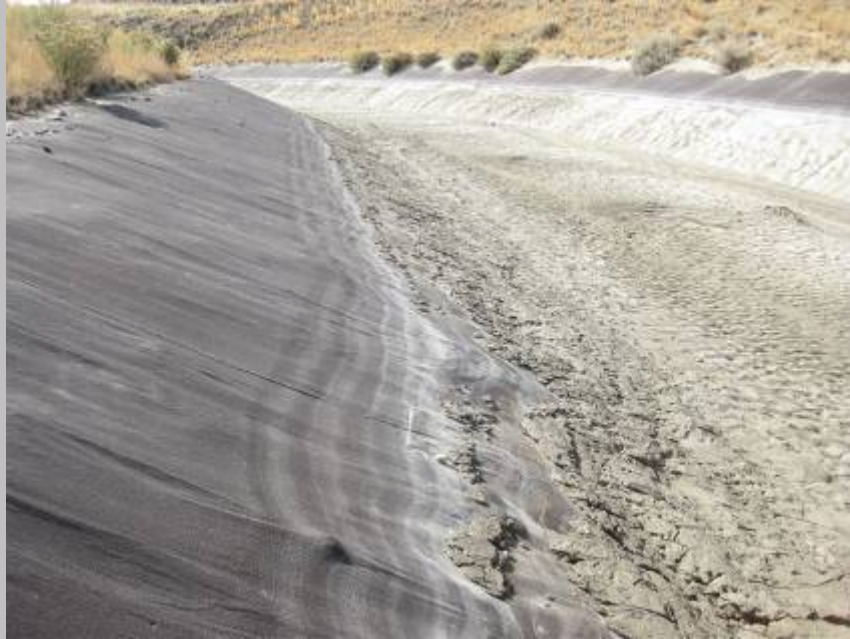
Comments: The image depicts the general condition of the irrigation canal. Note the exposed Teranap on the walls of the canal; this is the general area where Samples A1 and A2 were taken.

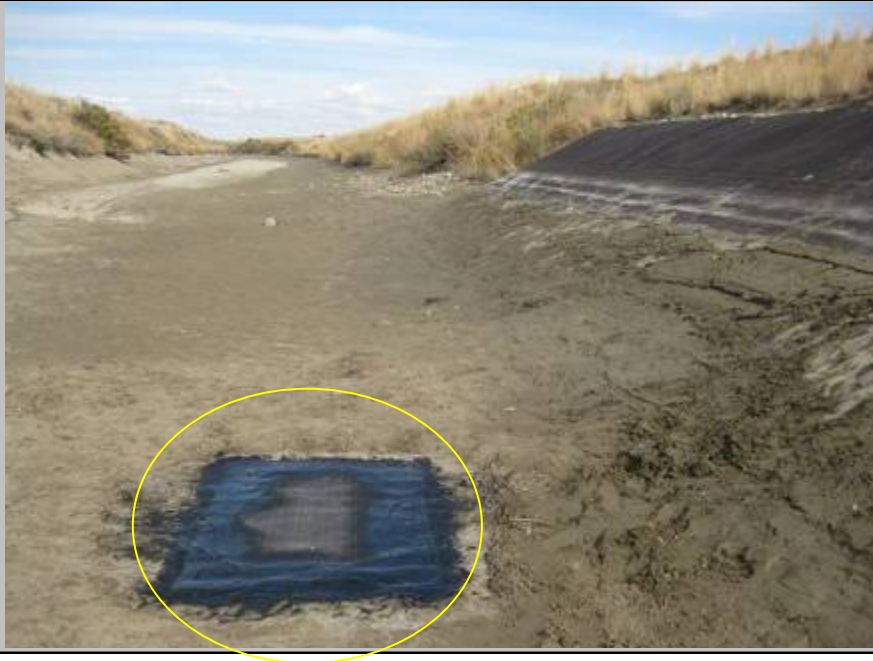
Comments: The image indicates where Sample B1 was extracted.

2. Sample B1 was extracted from beneath a layer of sediment in the bed of the canal. The sample had experienced limited, or no, direct exposure to UV. Due to the water and earth covering it is safe to say that this sample maintained a relatively constant and moderate temperature compared with the exposed samples A1 and A2.
